Five Historic Metal Truss Bridges

By Vern Mesler

Restoration of the Bauer Road Bridge

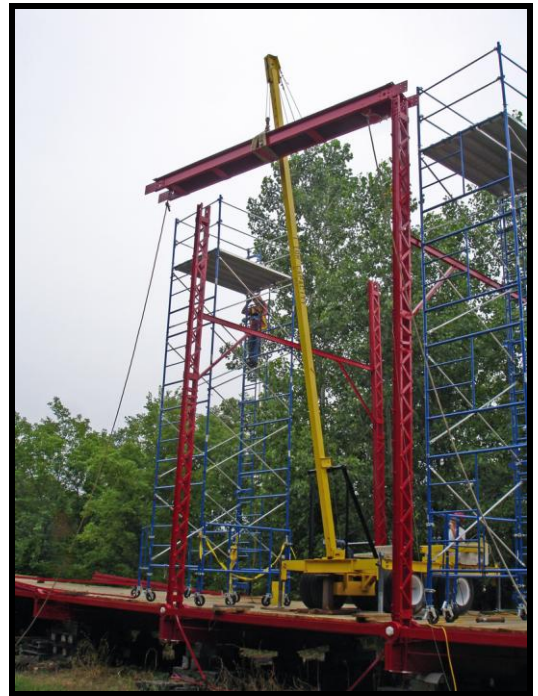
Gin Pole lifting a top chord section on the Charlotte Highway Bridge.

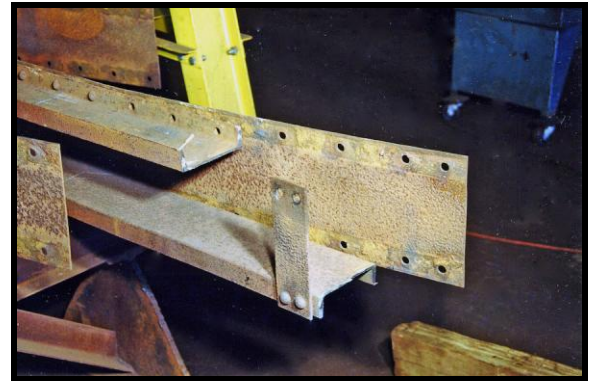
Inclined post sections cut a different length.

The corroded wrought iron sections of the Bauer Road Bridge inclined end posts were cut with a grinder. The top chord plate and two channels were cut at different lengths to avoid having welding splice in the same location.

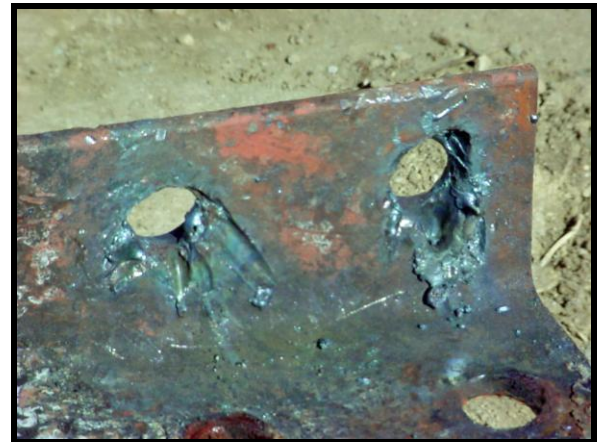
The Air Carbon Arc process was used to remove the rivets from the top plate of the inclined end post, the bridge pin reinforcing plate, and batten plates. The air carbon arc process is very efficient in removing rivets without damage to the historic parent metal. If the oxygen acetylene process is used with a rivet washing tip it can leave deep gouges requiring repairing, or replacement of the historic metal. The air carbon arc process is a valuable tool in the steel fabrication industry today.

Rivets removed with a torch washing tip, not recommended.

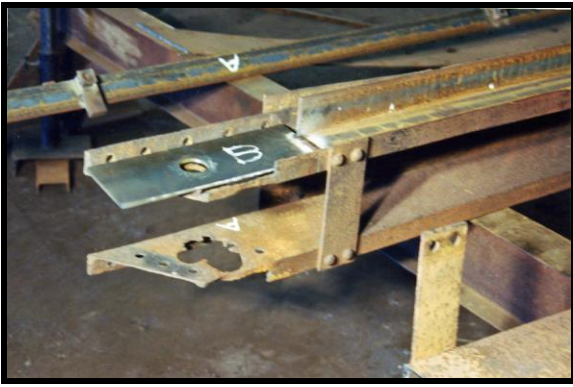
Splice Jig.

Before cutting off the corroded sections of the four inclined end post channel, a jig was fabricated that would maintain the hole dimension between the bearing end pad bridge pin, and the top chord bridge pin when attaching the replacement sections. Because wrought is a composite material of iron and slag fibers it can be difficult to cut with an oxygen acetylene cutting torch. When the oxygen cutting flame comes in contact with pockets of

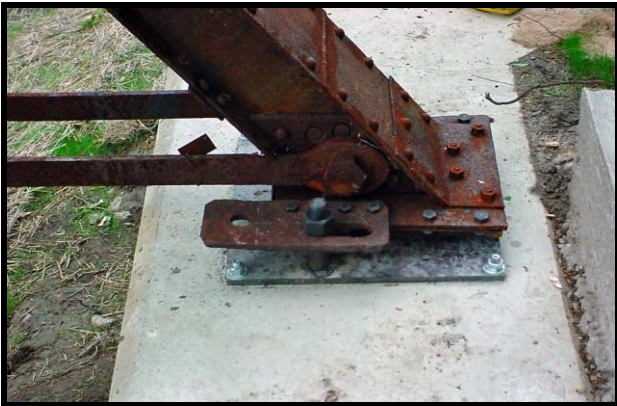
Splice sections were fabricated from the Tallman Road Bridge material, and the Bauer's bridge pin reinforcing plate was riveted to the splice sections. All welding was done to AWS welding standards with all full penetration welds made with E7018 electrodes. No grinding was done on the weld splices. This was to avoid scarring the metal surface with grind marks, to prevent section loss due grinding, and to allow inspection of the weld splices over the life of the bridge.

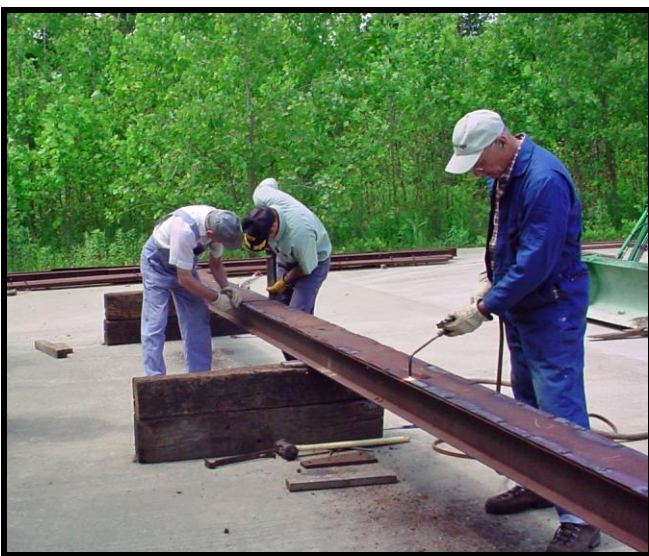
Removing pack rust from a Stearns truss bridge in Delphi Indiana

One of biggest issues with structural engineers when doing a structural analysis of older bridges is the buckling of the plate between rivets where pack rust forms between the plate and channel of the inclined end post and top chord plate. A procedure was developed at the Historic Bridge Park using a rivet gun to hammer out a buckle with the rust breaking up and driven from the buckle. To avoid the scarring and to get more impact from the hammering of the rivet gun the end of an old rivet gun snap welded ground to a blunt the end a steel plate with a handle was used as a buffer between the hammering of the rivet gun and buckle; it also keeps from scarring or case hardening

Sequencing of the heating to prevent distortion was used, that is to remove a few buckles in one area and move on to other buckles further away to keep from concentrating too much heat in one area.
