Five Historic Metal Truss Bridges

By Vern Mesler

Restoration of the Bauer Road Bridge

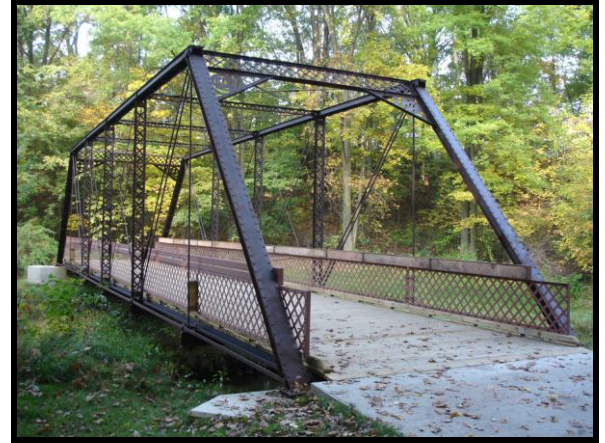
The restored Bauer Road Bridge now spans a small creek within the Historic Bridge Park. It is a bridge that could have been scrapped without any notice. Its age, simplicity, and the lack of understanding of this unique structure, left it without many friends. This wrought iron bridge, along with all historic metal truss bridges, has an unwritten story within its wrought iron members.
